Ref: Canal Run HOA Storm Water Lake Repairs

RMASSER <small>INSPECTED BY</small>	INSPECTOR'S REPORT	531046 <small>INSPECTION #</small>
11434 <small>PERMIT #</small>	CANAL RUN REGIONAL SWM/LAKE <small>PROJECT NAME</small>	
SWM MAINTENANCE TRIENNIAL INSP <small>TYPE OF INSPECTION</small>	Thu - 05/02/2013 <small>INSPECTION DATE</small>	FAILED <small>INSP STATUS</small>

Exhibit B – Supplemental Guidance to Exhibit A

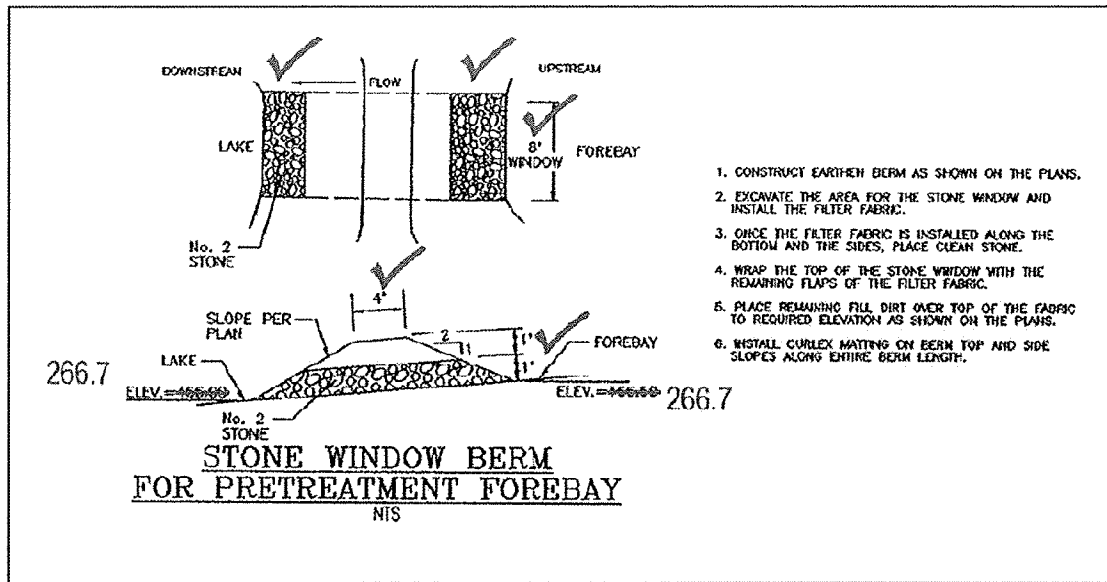
Item #2: Forebay outlet window repair. Please refer to the following:

- The area of the drawing detail I've highlighted in yellow represents where the earthen berm portion is currently missing [washed away] from the forebay outlets. The additionally highlighted numbers 5 and 6 are those steps required to repair these devices.

08-Earthen portion of forebay window washed away. Replace with clayey material, compact and stabilize.

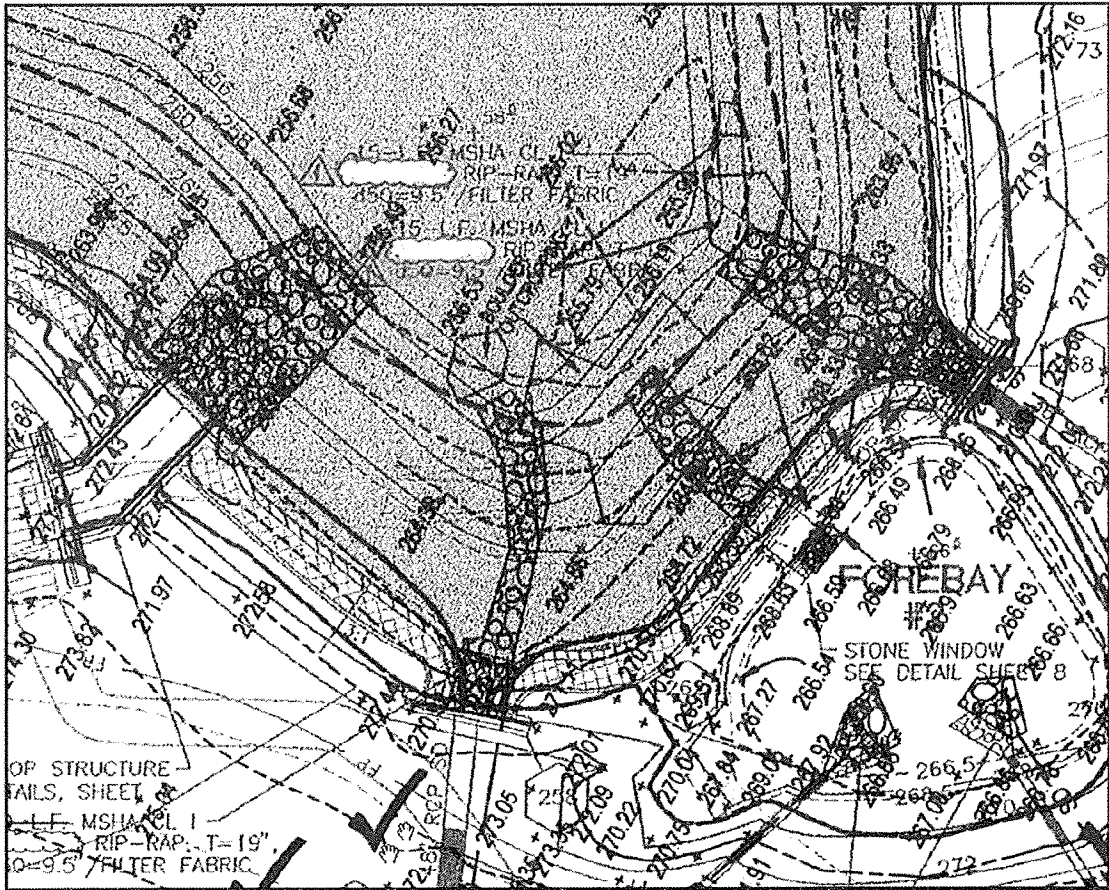
Item #3: Rip-Rap Outlet Protection [RROP] Repair.

- depicts an area in the southwest corner of the lake, where a lot [not all] of the damage occurred to the RROP.

- MSHA Class I Rip-Rap [Stones weighing no less than 2-LBS and no more than 150-LBS]
- Installed in a bed depth of 19-IN [Bed depth is measured below surrounding grade]
- $d_{50} = 9.5$ [50% of the stone diameter will be above 9.5-IN and 50% of the stone diameter will be below 9.5-IN]
- Installed over filter fabric

The clouds cover what was originally specified to be "Grouted" [high slump concrete poured into the rip-rap bed]. This measure is generally used to fill the voids and lock the rip-rap together, making it a more cohesive unit that is less likely to be displaced.

However, call-out /1\ below states "Rev[ised] per MDE Comments"

- This would appear to suggest that grouting the rip-rap bed was not recommended by MDE.
- Based on the failure of the non-grouted rip-rap to hold in these areas, I recommend that grouting of the RROP be revisited with MDE (if necessary) and be restored as the recommended detail or be replaced with another detail. Options may include using larger rip-rap, embrocated rip-rap, gabion mattress or another material or procedure that can withstand the apparent velocity of flow entering the channels.
