**Lake Report 2013-2014**  
**Thomas Wellock**

**Introduction:** This report to the Board of the Canal Run Homeowners Association (HOA) summarizes work I completed on my own and done in cooperation with Rick Masser, the Chief Environmental Compliance Inspector with Frederick County and Canal Run's Developer, Andy Macintosh, to improve the ability of the stormwater management lake to retain water and increase the supply of water to it. These actions have been taken in response to questions raised in the HOA about the adequacy of the lake system. Much of this work was completed pursuant to an agreement signed on May 21, 2013 between the Developer and the HOA. This report also provides background information and data to give context to the current condition of the lake.

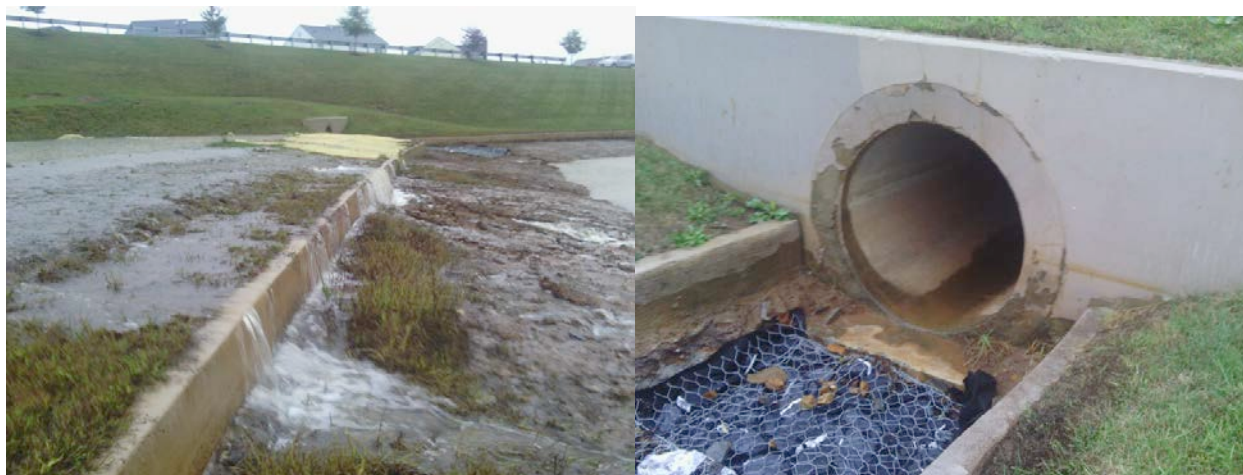
A change in the weather soon revealed new problems with the lake system. The heavy rains in early October 2013—7.39 inches in about a week—were of such magnitude that they completely refilled the lake. The large inflow of water revealed design flaws in the stormwater discharge system. Stormwater enters a small underground room called a splitter (see Figure 4 on page 10). The splitter is designed to send small amounts of early storm runoff to the lake’s two forebays, which look like small ponds next to the lake. (see Figure 2 and Appendix A) The forebays act as an anti-pollution, water-filtration system. As a storm builds in intensity, the bulk of the runoff is supposed to feed directly to the lake through the three large outfall pipes next to the forebays (see Appendix A photo for outfall locations). This was not happening. All of the runoff entering the splitters flowed exclusively to the two forebays. The flow was so large that it overwhelmed the discharge opening in the forebays, known as a “weir windows,” leading to the lake.<sup>10</sup> Instead, the water discharged across the entire front of the forebay. (Figure 2)

**FIGURE 2—Overflowing forebay near the clubhouse, October 11, 2013. Meanwhile the large outfall pipe near the clubhouse discharged almost no water to the lake.**

This was a problem for two reasons. 1) In large storms, this defect caused substantial erosion in the lakebed near the forebays, and in time would damage the forebays themselves. 2) Much of the water entering the forebays did not reach the lake. Instead it percolated into the ground reducing the supply of water to the lake.

I sent these photos to Rick Masser. Given the design flaws in the system, Masser concluded that the lake could not pass inspection. He insisted the forebay piping be restricted with orifice plates (Figure 3) and to improve the weir windows, openings in the forebay that spill water to the lake.<sup>11</sup> This work was completed under the 2013 agreement. Thus, without incurring HOA expense, the system was redesigned to ensure proper function, reduce maintenance costs, and improve the volume of water flowing to the lake.

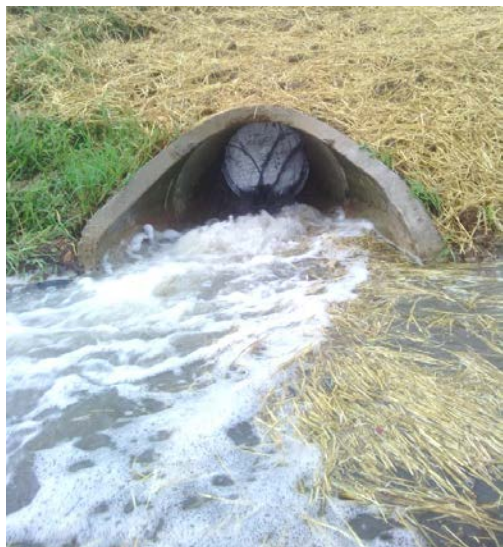
**FIGURE 3:** The lightly shaded area seen inside the pipe is an orifice plate to limit stormwater flow to the forebay. Limiting flow to the forebay directs more water to the lake.

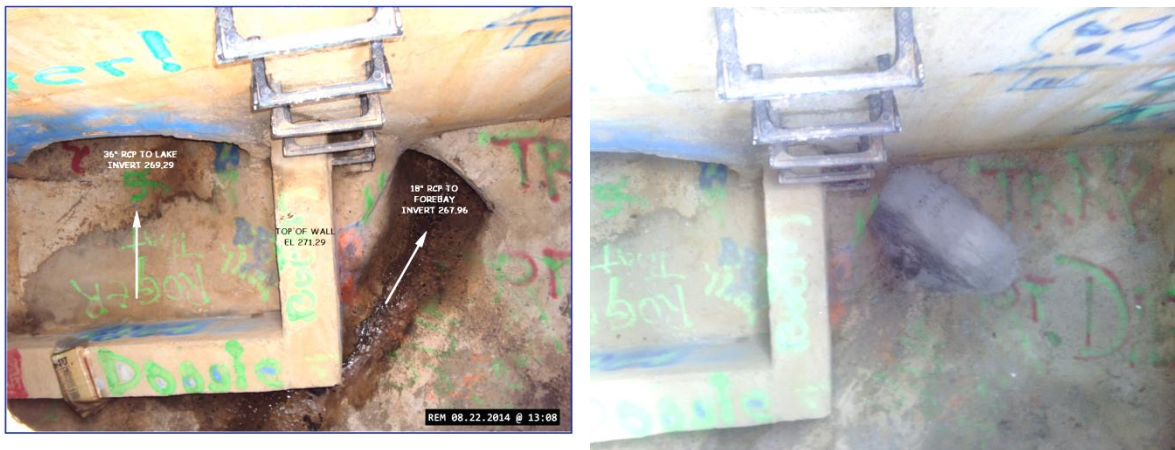
**FIGURE 4:** The “splitter” in these two images sends early stormwater to the forebay through the 18 inch pipe on the right of the image. As larger volumes flow to the splitter, water is supposed to back up and spill to the 36 in pipe on the left side leading to the lake. However, the 18 inch pipe was too large for its intended purpose and water rarely went to the lake. The image on the right shows the 18” opening restricted to only a 4” opening. The other two splitters should receive the same modification.

I do not believe, however, that the completed design is optimal. While the system now meets County approval, there is still too much water flowing to the forebays, especially near the clubhouse (figure 3). Further restricting the pipe will divert more water to the lake. I have consulted with Rick Masser on this issue. He has no objection to the HOA adding the brickwork installed in one splitter in to the other two. (See Figures 4 & 5) I recommend funding these modifications. An informal estimate provided to me indicates the work would cost about \$1,500, but this needs to be confirmed.

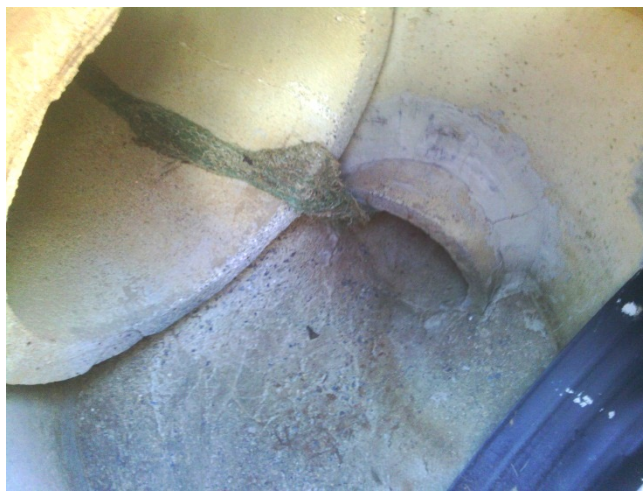
**FIGURE 5:** Due to its contoured shape, the splitter near the clubhouse will be more difficult to restrict as was done in Figure 4. The HOA should seek out cost estimates.

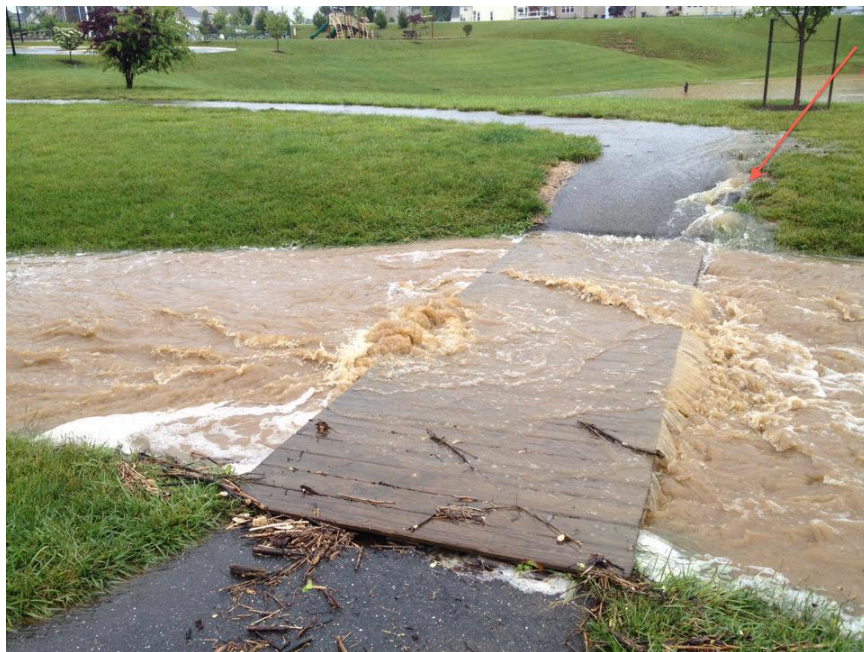
In June and July of 2014, I noticed another problem with the drainage to the lake. The heavy rains of the late spring had engorged the stream feeding the lake (Figure 6). What caught my eye in this photo, was not the flow of water over the bridge but the water running down the path toward the bridge. There were clear signs of erosion to the path (Figure 7). This was clearly a reason why there had been potholes on the approach to the bridge in the past year. Where was this water coming from?

**FIGURE 6:** Across from the bridge, water can be seen running down the walking path.

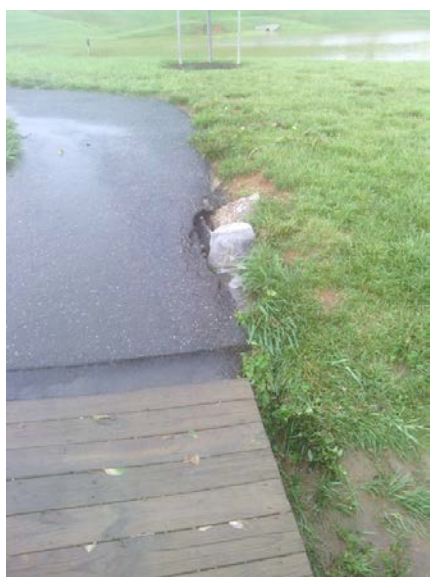
**FIGURE 7:** Erosion near bridge.

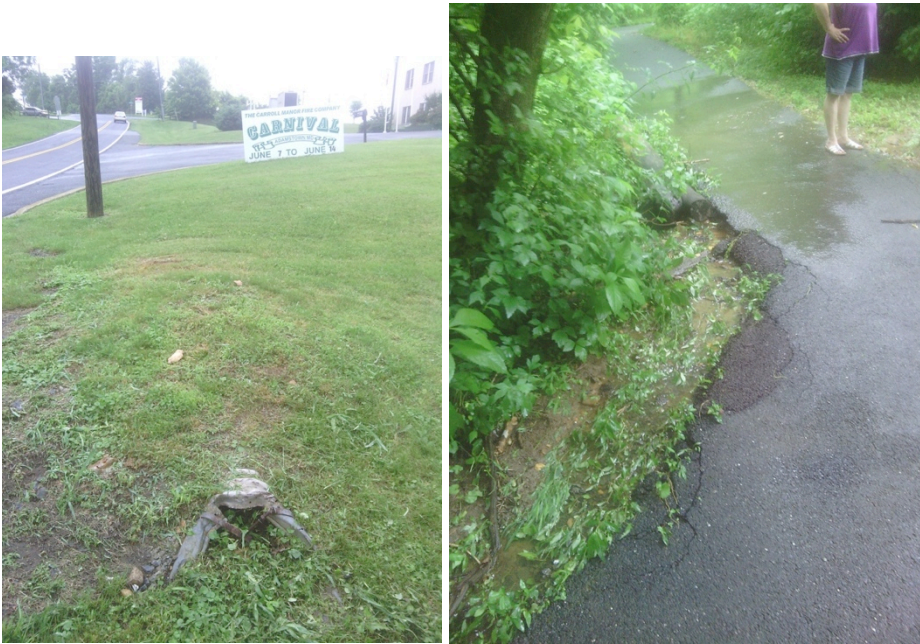
The path's stream led all the way to Ballenger Creek Pike. Much of the runoff from the intersection of Lockhouse Drive and Ballenger Creek Pike does not reach the stream. Instead it turns off down the HOA walking path, picks up a contribution from a drainpipe at the firehouse, and forms a stream running down

**FIGURE 8:** This drain pipe near Ballenger Creek Pike discharges to the walking path (left). The water damage to the walking path is evident in the image on the right.

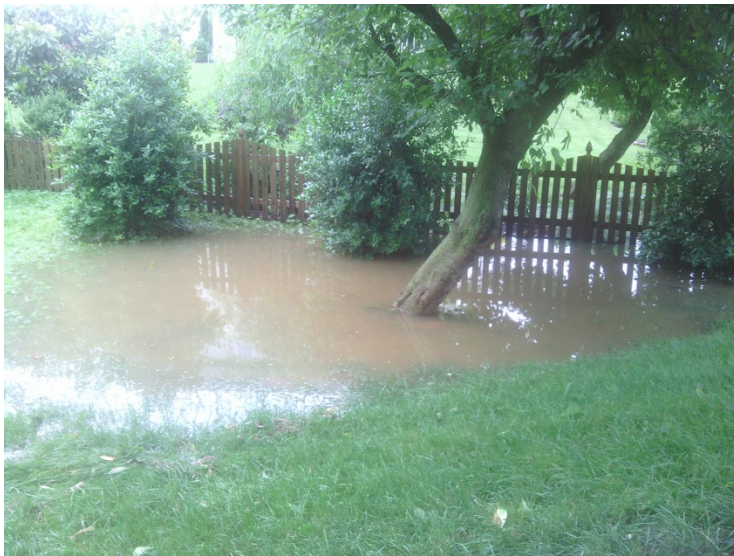
**FIGURE 9:** Flooded back yard on Canal Clipper Court due runoff from Ballenger Creek Pike.

There are several reasons why the HOA should remedy this situation. (1) The stream flow will continue to erode the path and the footing for the new footbridge. (2) The water is flooding the yards of homeowners on Canal Clipper Court. (3) The water that ends up in the yards on Canal Clipper Court is absorbed and doesn't make it to the lake. (4) Directing more water into the stream should result in an increase to the lake level.

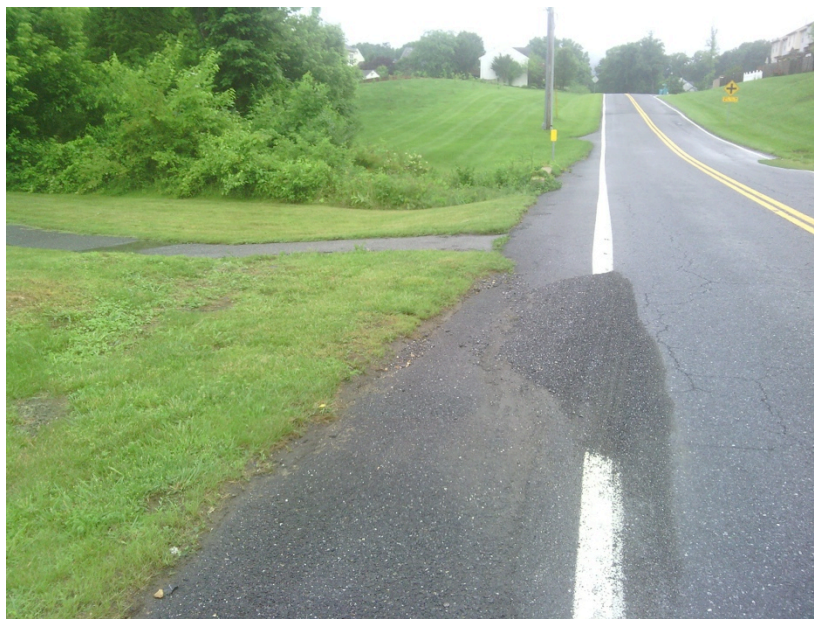
**FIGURE 10:** Runoff from the road needs to be directed to the stream. Developer work on the nearby culvert may solve this problem.

of the area with Rick Masser and Board President Mark Hershfield, Masser indicated that the culvert work can be modified to capture the runoff from the road and divert it to the stream and away from the path (Figure 10). This work by the Developer, however, may not be done until the spring or summer of 2015. A member of the Board needs to be tasked with keeping track of this work and ensuring that the work on the culvert suits the HOA's needs.

Even with this work by the Developer, a drain may still be needed to capture the runoff from the firehouse and direct it to the stream. It is likely this work could be done with a relatively simple drain trench run under the path.

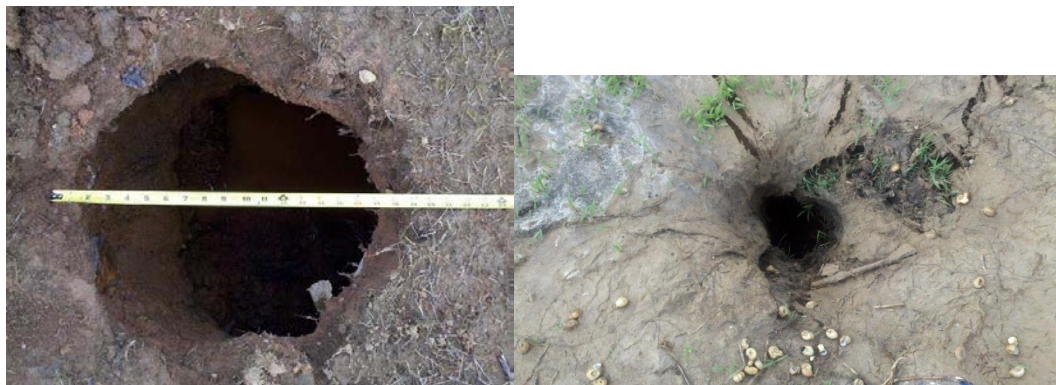
A sinkhole identified in the HOA's 2012 consultant report (left). It's almost 18" wide. At right, a sinkhole identified in 2011; it is only 5 inches wide.

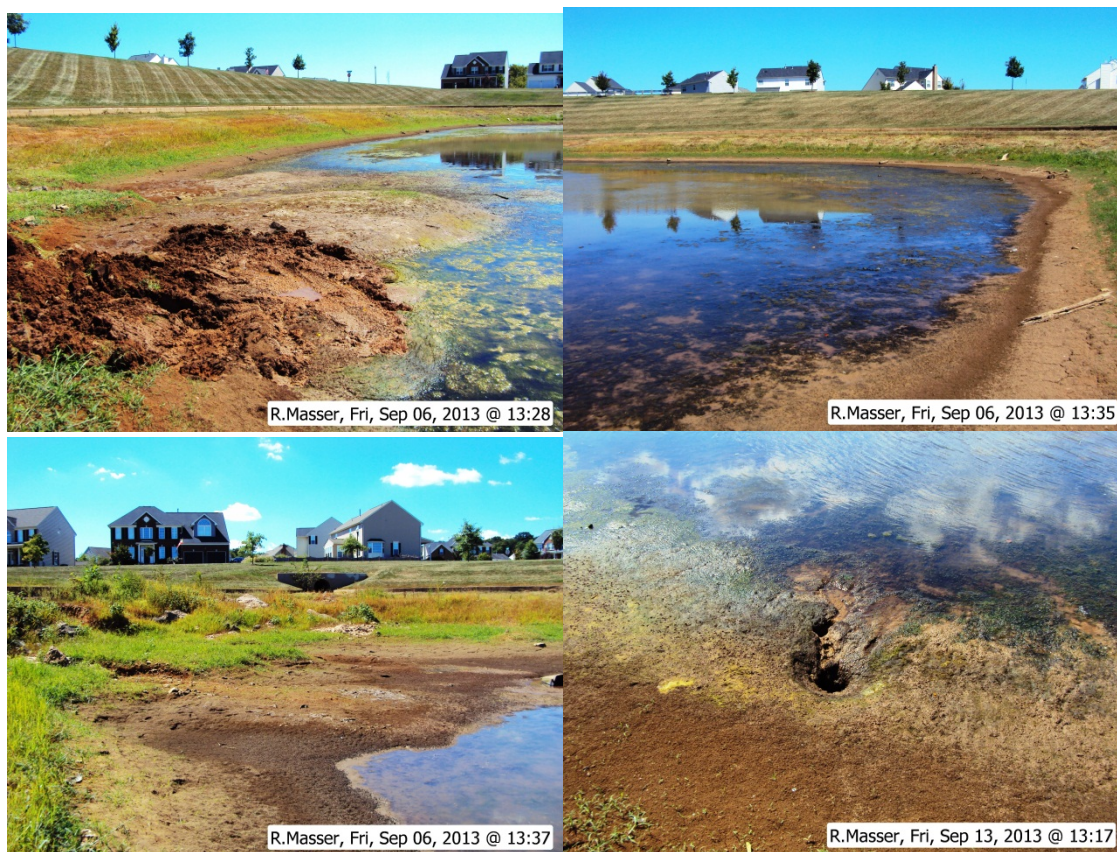
Images of the lake just prior to commencing repairs on the sinkholes.

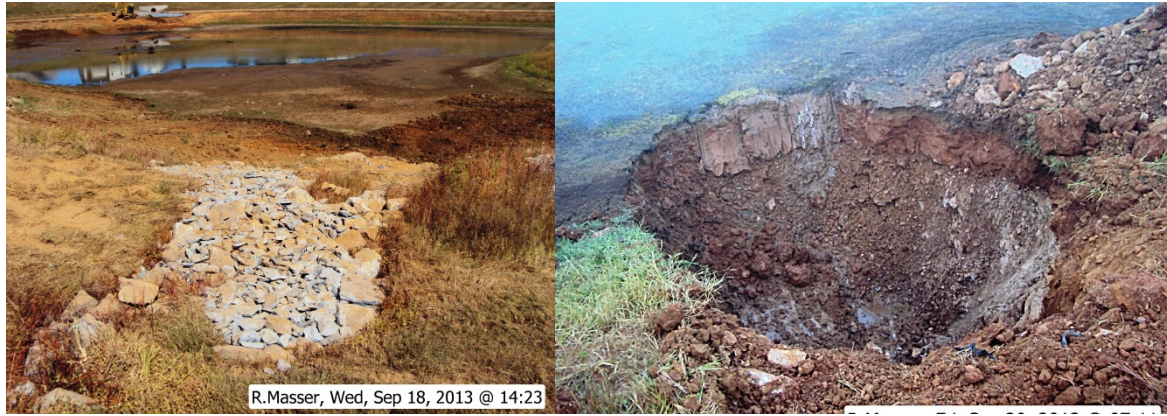
**Lake view just before work began on sinkholes (left). Excavation of sinkhole during repair work (right).**

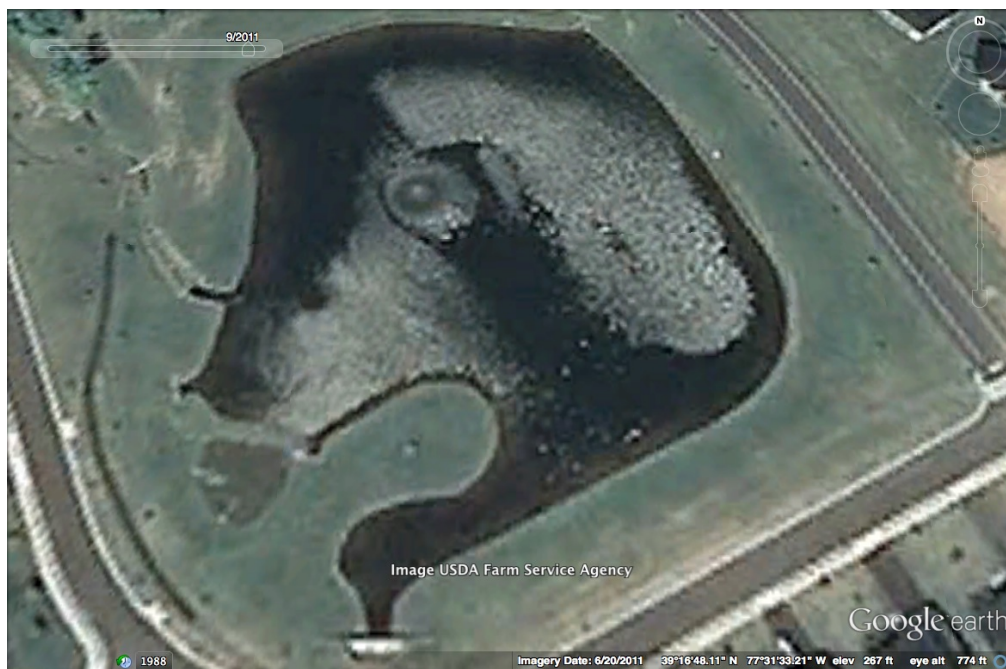
**June 2011 was the only time in Google Earth's collection where the lake is captured when full. 2011 was an extremely wet year.**
