REPORT OF GEOTECHNICAL EVALUATION

Canal Run Regional SWM Pond Frederick County, Maryland

November 15, 2012

GTA Job No: 121294

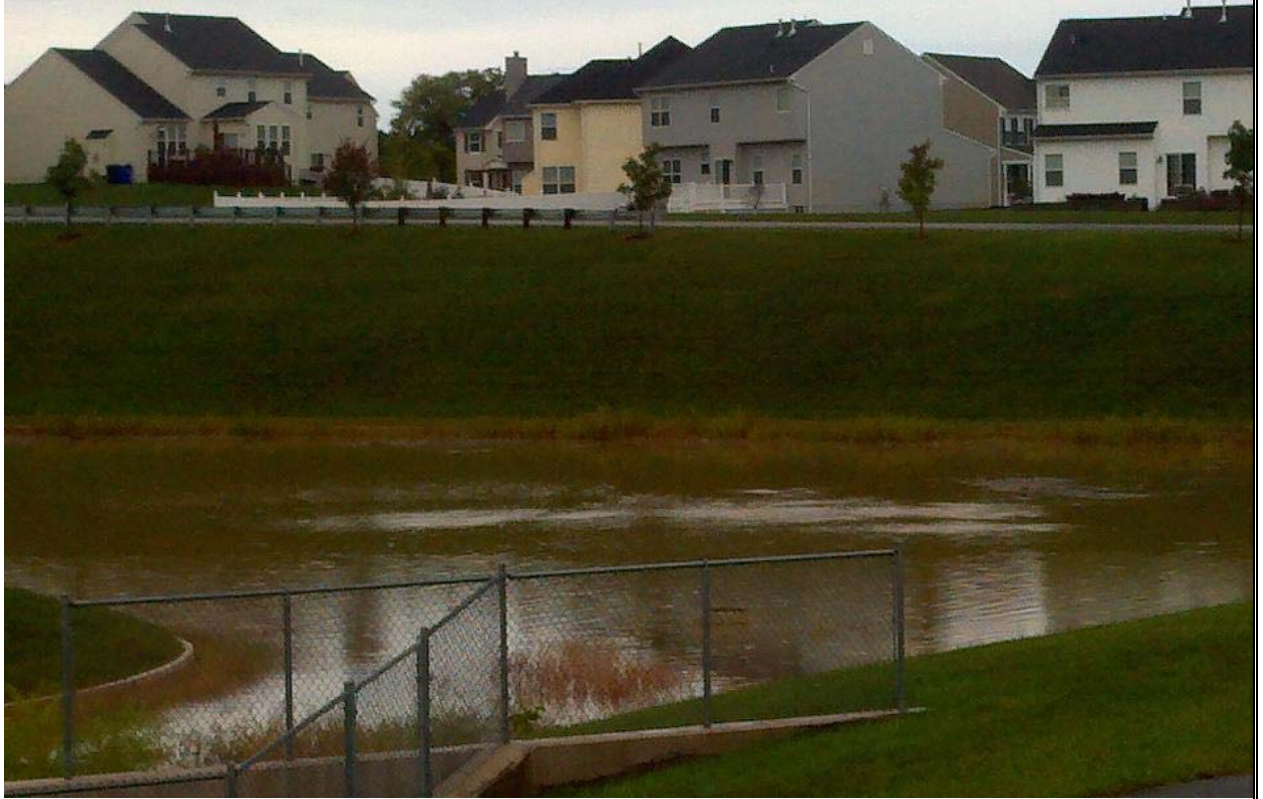
The typical wet pool is significantly lower than El. 266. Several sink holes were observed between the wet pool and El. 266 (bottom of existing retaining wall) as shown on photographs #2 through #4. In addition, when the pool gets to be near the normal wet pool elevation, bubbles are observed in the middle of the lake as shown on photograph #1.

Due to lack of clay liner, sinkholes are forming throughout the basin area. The bubbles within the water surface indicate that water is being lost through possible path at the bottom of the pond and releasing the air causing the bubbles at the surface. The possible paths can be sinkholes formed at the bottom of the lake.

Photograph 1: View of the lake with “bubble” in the middle of pond.

The issues present that is hindering the proper functioning of the pond is construction related and not related to maintenance of the pond. GTA recommends that the facility be dewatered and the clay liner be installed to El. 266. The clay liner should be at least 18-inches thick and consist of material having a minimum permeability of 10^{-7} cm/sec. During the same process and prior to placement of the clay liner, the sinkholes present at the bottom of the basin should be filled up to the throat of the hole with zero slump concrete.

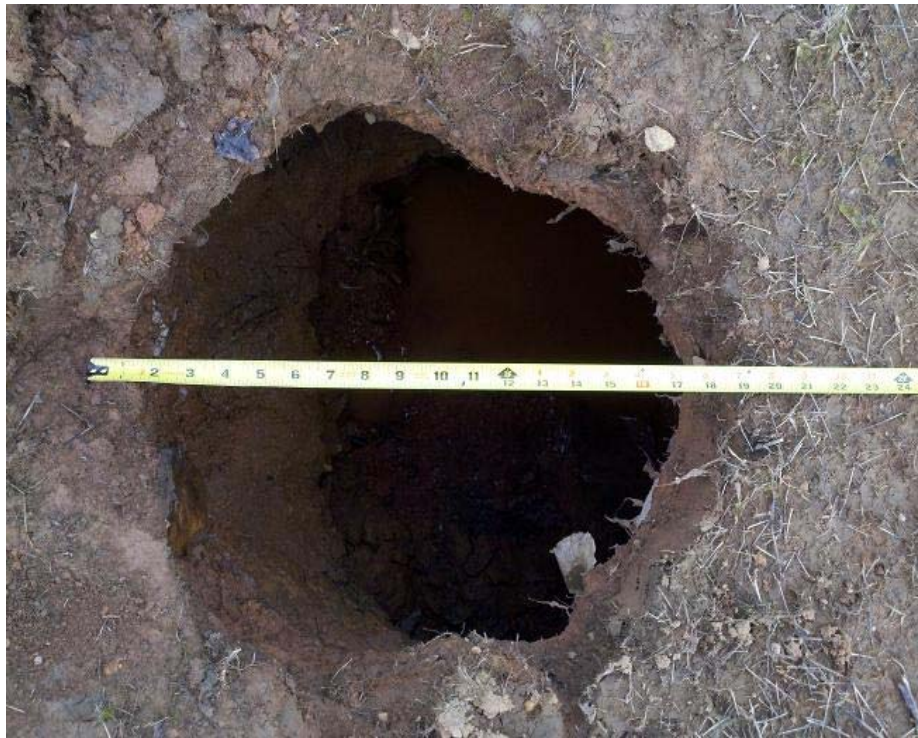
Photograph 2: View of sinkhole between the pool and retaining wall.

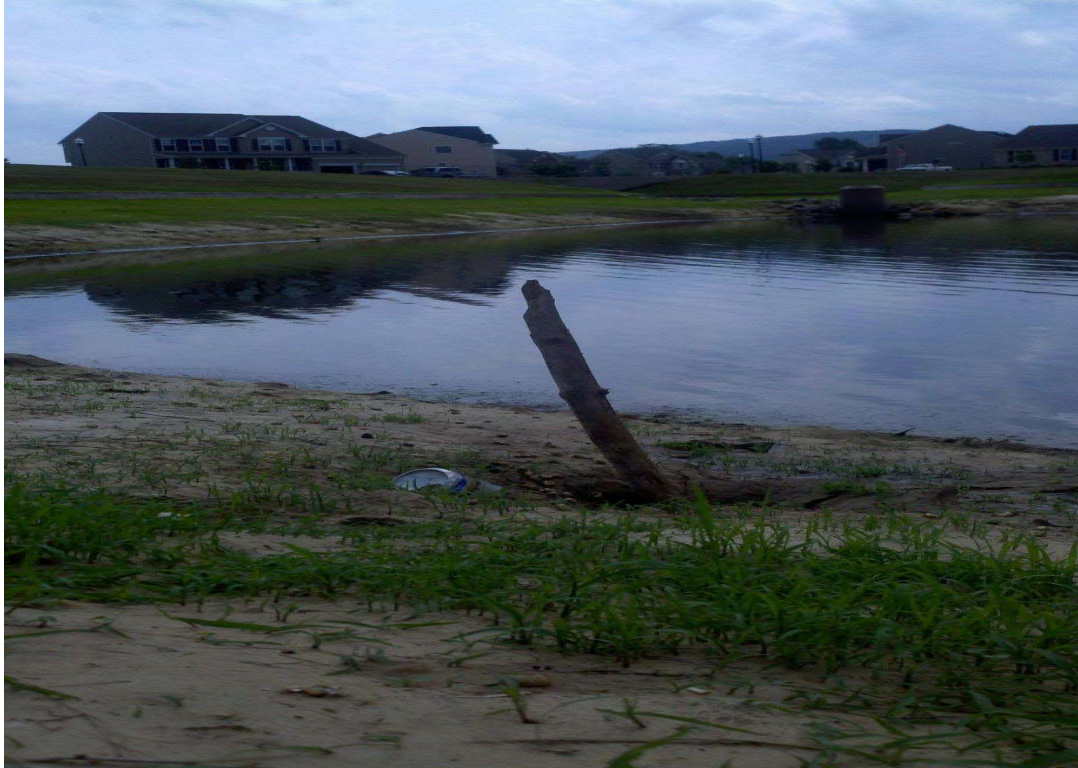
Photograph 3: View of the sinkhole location (with a stick).

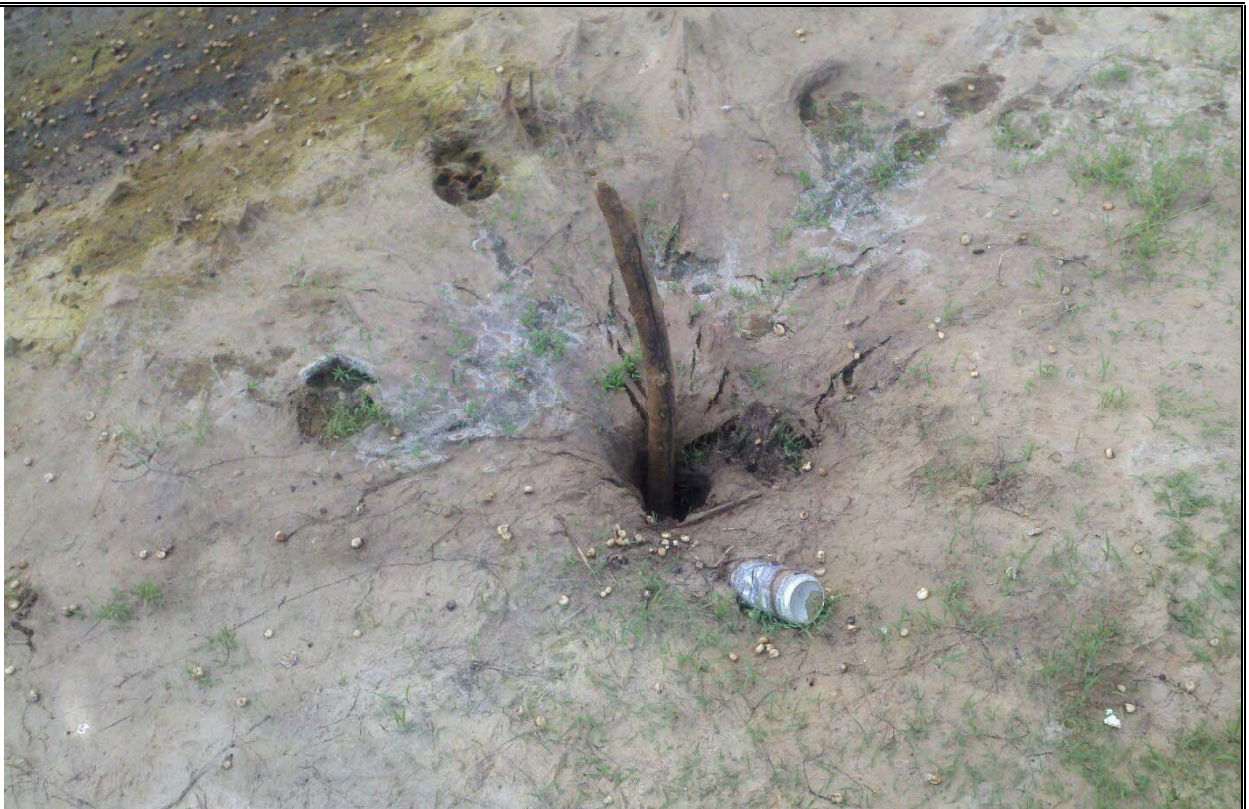
Photograph 4: Sinkhole in between the pool and the retaining wall.
