MEMORANDUM TO : Canal Run HOA Board of Directors

SUBJECT : Report on the condition of the Townhouse area

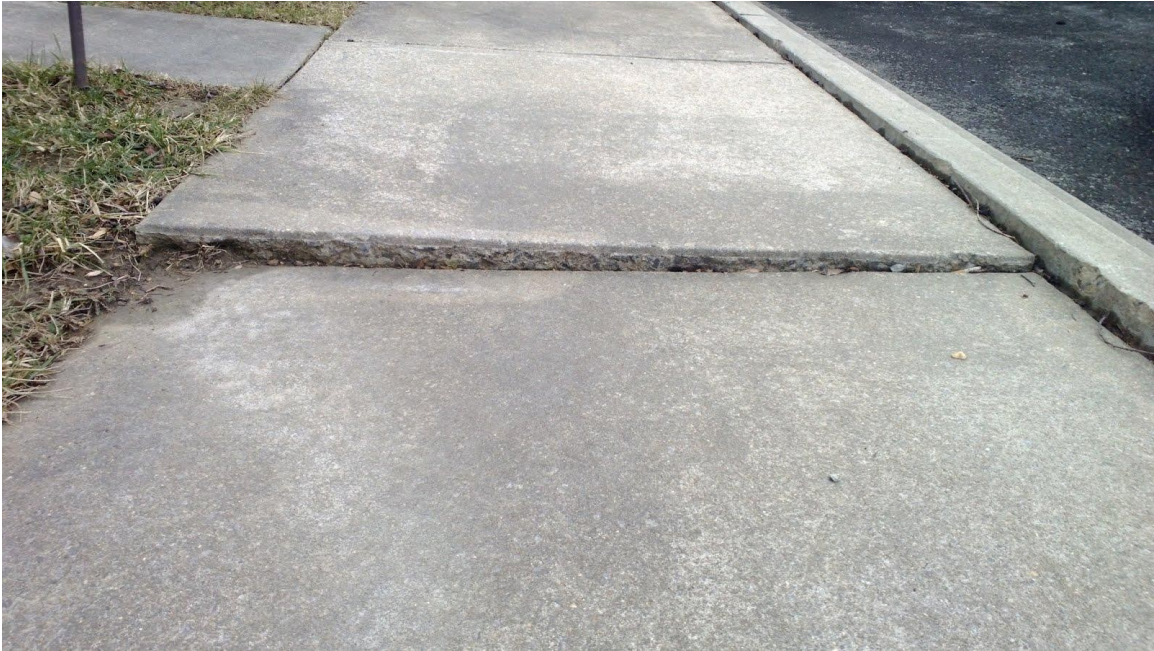
#### **2 Uneven Sidewalks**

Upon an inspection of the townhouse area it was noticed that sidewalks located in front of Unit 2190 are uneven and one is lifting up. Such uneven sidewalks are an impediment to foot traffic and a general eye sore to the community. Other sidewalk areas were observed to be in a condition in need of repairs (such a fact is to be expected as some of the sidewalks have existed for over a decade and sidewalks need periodic maintenance).

- 1 The HOA should continue a dialogue with the Frederick County Community Development Division to make the responsible parties aware of the issues with sidewalks in the townhouse area.

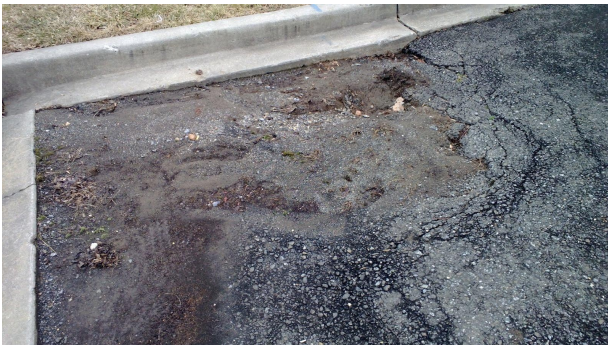
During the inspection, individuals from the Community Development Division noted that two inlets on the far right side of the parking lot are in disrepair. They noted that this could cause problems for any car that parked in front of the inlet. The inspectors indicated that repairs to the inlets would have to take place prior to the top coating and that the needed repair could be extensive.

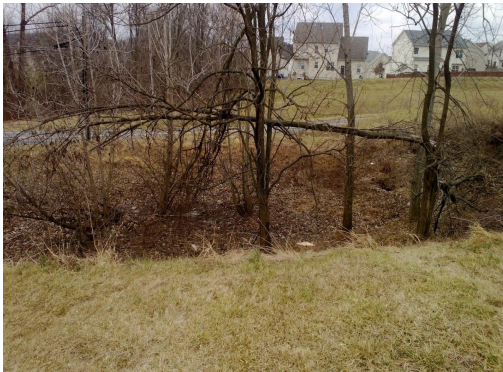
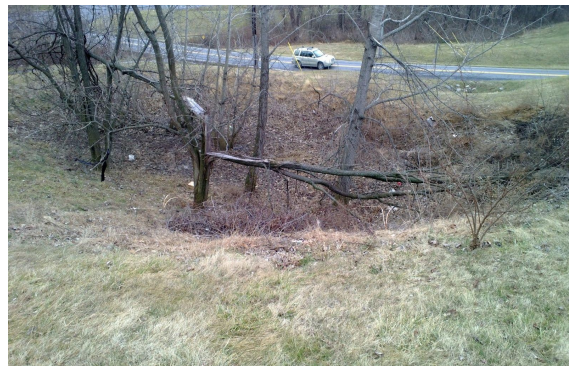
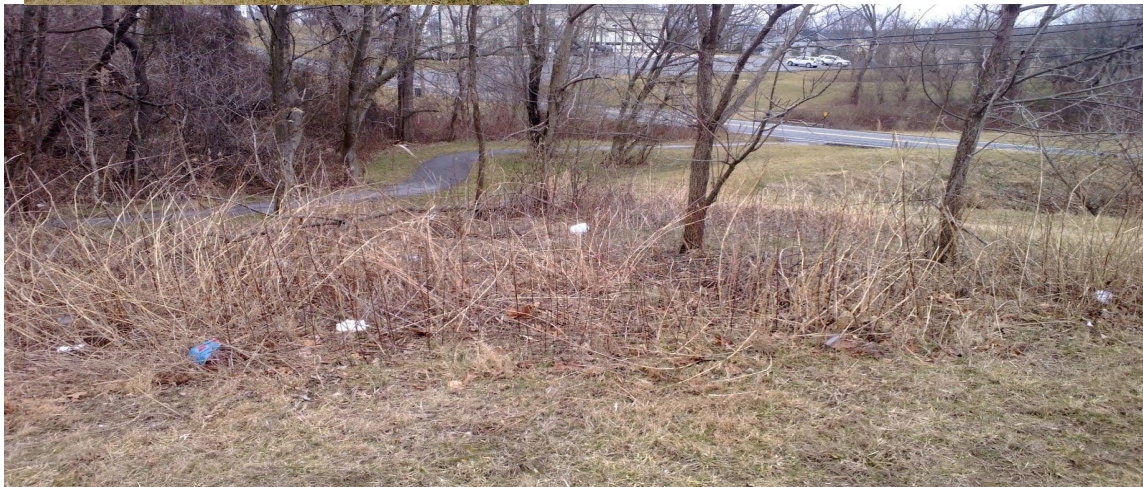
### 1 Retention Pond (Biofilter) and Accompanying area

There is a retention pond located in the corner of Swains Lock Ct. The Phase IT plan identifies it as a water quality facility and the Phase 6B plan did not alter this designation. After discussions with the Frederick County Community Development Division responsible for Storm water management facilities, the retention pond was identified as a biofilter, which was transferred over to the HOA (most likely in April 2010 along with the other common areas in the community). The biofilter has lots of over growth and trees in the area. Some of the trees appear to be dead and take away from the aesthetics of the area. In addition, garbage is collecting in this area.

In close proximity to the biofilter there is a small area of land that appears to have never been landscaped. A review of landscaping maps provided by the developer to the HOA does not indicate any reason why this area is not subject to general land maintenance practices (i.e. lawn mowing).

- 5 The HOA should have Frederick County officials inspect the biofilter and make recommendations to the HOA on how to increase the aesthetic value of the area.

- 6 Prior to the inspection, the HOA, through the Beautification Committee, should sponsor a clean up day focused on cleaning up the biofilter area.
- 7 The HOA should work with the landscaping company to ensure that all common areas in the townhouse area are receiving the proper landscaping treatment going forward.

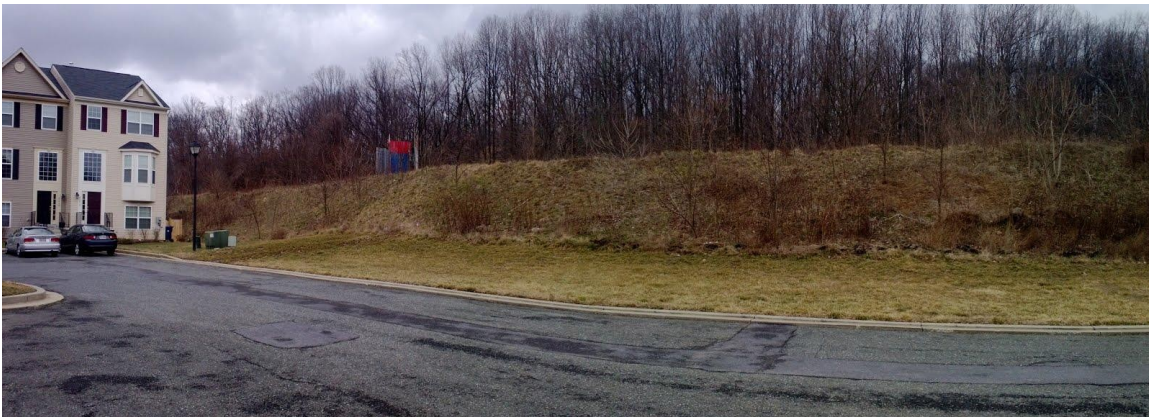
## **2 Sound Barrier (Separation wall between Townhouses and US Route 15)**

Per the original building maps for the townhouse area, the property bordering US Route 15 was supposed to be a line of townhouse, but due to planning changes that took place prior to the submission of the Phase 6B plan they were not built. In their place a large hill was created to separate US Route 15 from the Townhouse area. This hill appears to have never been landscaped at all. The map provided by the developer does not clarify who owns this area. The Phase 6B plan, however, indicates that the entire sound barrier is common area that has been transferred over to the HOA. The area is full of overgrowth and does not match the surrounding character of the community.

- 8 The HOA should create a plan to enhance the aesthetics of the sound barrier in the townhouse area.
- 9 The HOA should work with Frederick County to ensure that all vegetation listed in Page 9 of the Phase 6B, which is associated with the townhouse area, be put in place immediately, including the replacement of trees that have been removed at no fault of the HOA.

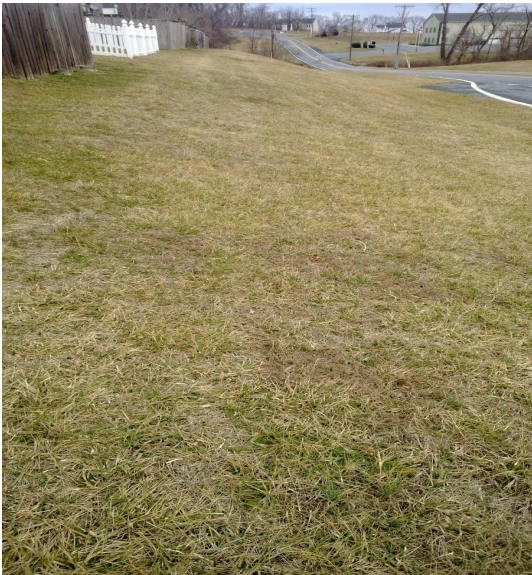
#### **4 Additional trees/vegetation**

The townhouse area is objectively not an area with much vegetation. A review of Page 9 of the Phase 6B plan indicates that this should not be the case. All total the townhouse area and water tower lots should have 454 plants/trees. Of significance, most of this vegetation is supposed to exist in the townhouse area, yet is not presently in place. This includes about a quarter of the plants, which are supposed to be placed in the easement between the original row of townhouse units in Ballenger Creek Pike. This also includes a Maple tree next to the court of townhouses on the left side of the court and additional vegetation in areas all around the court.

Vegetation is essential to the aesthetics of any community. The lack of vegetation, even though some townhouses have been completed for over thirteen years, hinders the resale value of the units. The existing vegetation simply does not come close to matching what is ultimately planned for this area of the community.

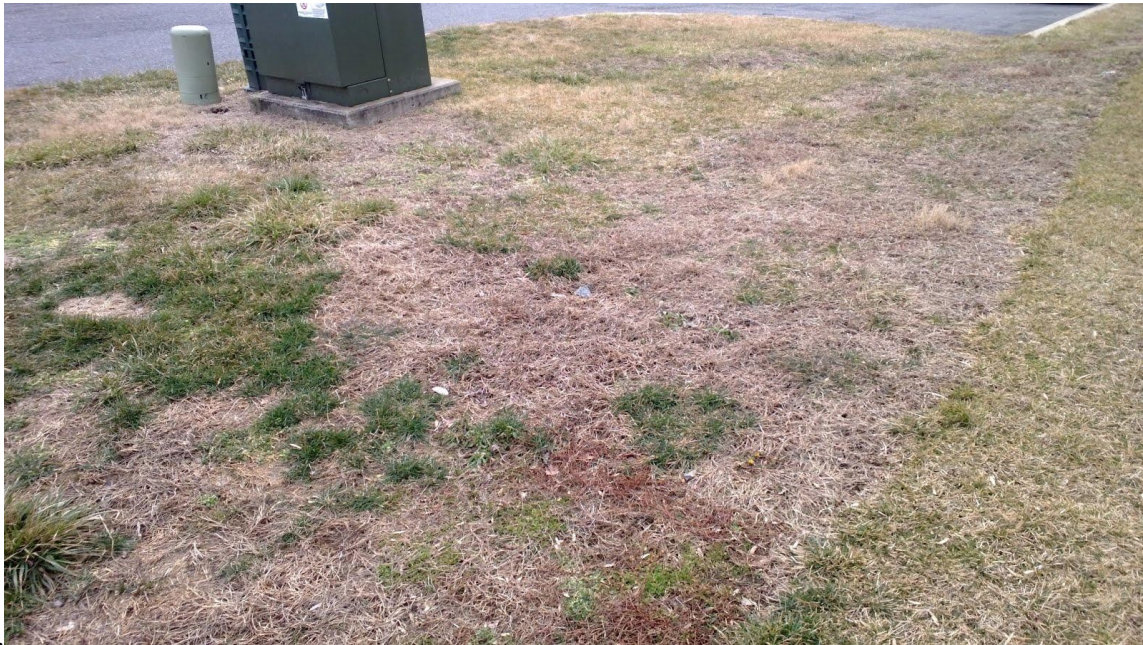
## **6 Common area next to Unit 2160**

The Common area next to Lot 2160 upon inspection appears to have never been completed. The area looks to have never had sod put down and is currently covered in weed growth. An inspection of all of the maps does not explain why this particular area has not been treated. The area has been transferred over to the HOA according to the developer.

- 11 The HOA should work with Frederick County to ensure that the common area near Unit 2160 is of the same quality as the surrounding areas or alternatively develop a plan to at a minimum replace the overgrowth with flowers or plants.
- 12 The HOA, through the Beautification Committee, should engage in conversations with Insignia Homes and the Developer to create a plan to improve the entrance to the Townhouse area with the goal of agreeing to share the expenses for such improvements.
- 13 The HOA should work with the Community Development Division to ensure that the Developer secures the yard inlet behind Unit 2160.
- 14 The HOA should look into the cost of erecting a fence or wall between a field and Ballenger Creek Pike.

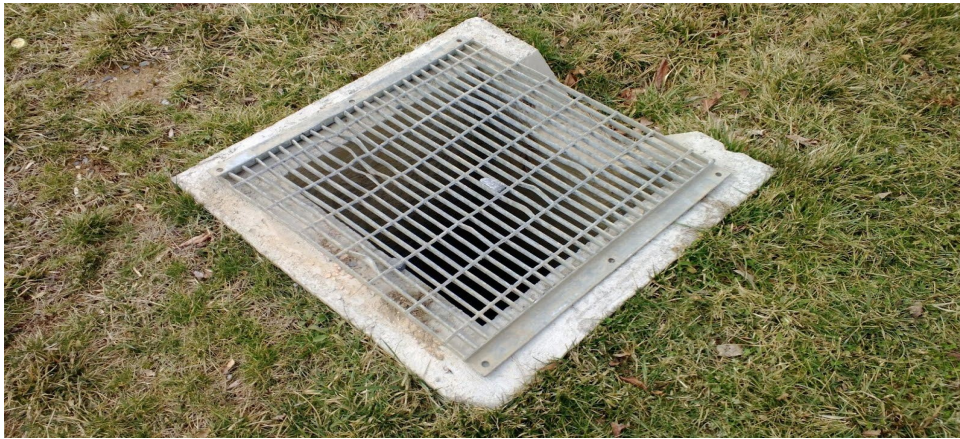
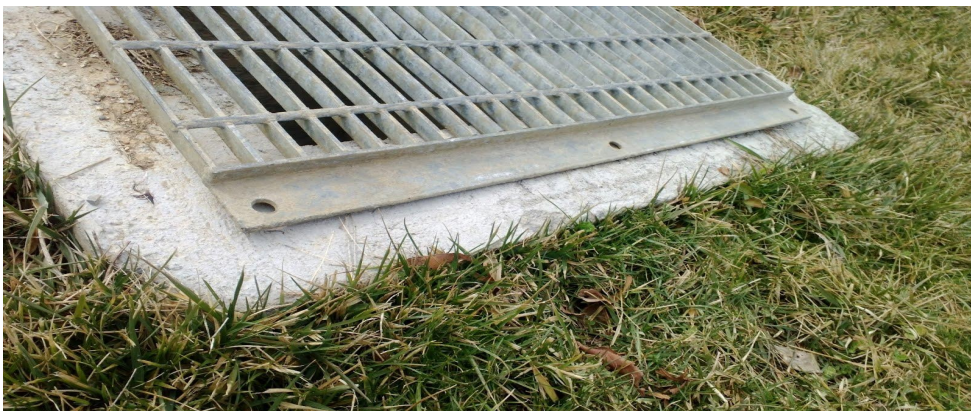
## 2 Yard inlet located behind Unit 2160

There is a yard inlet that is located behind Unit 2160. After examination the grate was just placed on top of a deep concrete drain. The grate can be lifted and removed with ease (as task force members did with ease during the visit to the

area). The existence of such a grate poses a significant safety risk to the community. The grate is listed on the Phase 1T and Phase 6B plans. The Community Development Division staff has repeatedly stated that all amenities and structure indicated on the plan must be completed and inspected prior to bond release. The inspectors from the Community Development Division were also note sure of the purpose of the yard inlet and listed it as an item to follow up on.

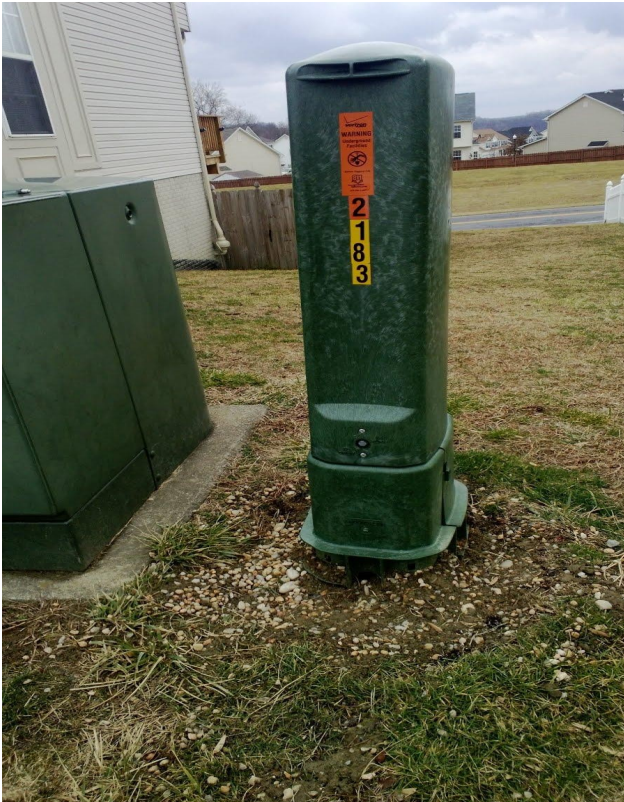
### 4 Verizon Box 2183 (Located between Unit 2161 & 2163)

Residents indicate that children have been playing on this box and it is coming out of the ground. Upon inspection by the task force, the box does not appear to be properly placed in the area and therefore poses a safety risk to the residents. Task force members reached out to Verizon about the box. On February 15th, Verizon staff came out and fixed the box.
