**Lake Report 2013-2014**  
**Thomas Wellock**

**Introduction:** This report to the Board of the Canal Run Homeowners Association (HOA) summarizes work I completed on my own and done in cooperation with Rick Masser, the Chief Environmental Compliance Inspector with Frederick County and Canal Run's Developer, Andy Macintosh, to improve the ability of the stormwater management lake to retain water and increase the supply of water to it. These actions have been taken in response to questions raised in the HOA about the adequacy of the lake system. Much of this work was completed pursuant to an agreement signed on May 21, 2013 between the Developer and the HOA. This report also provides background information and data to give context to the current condition of the lake.

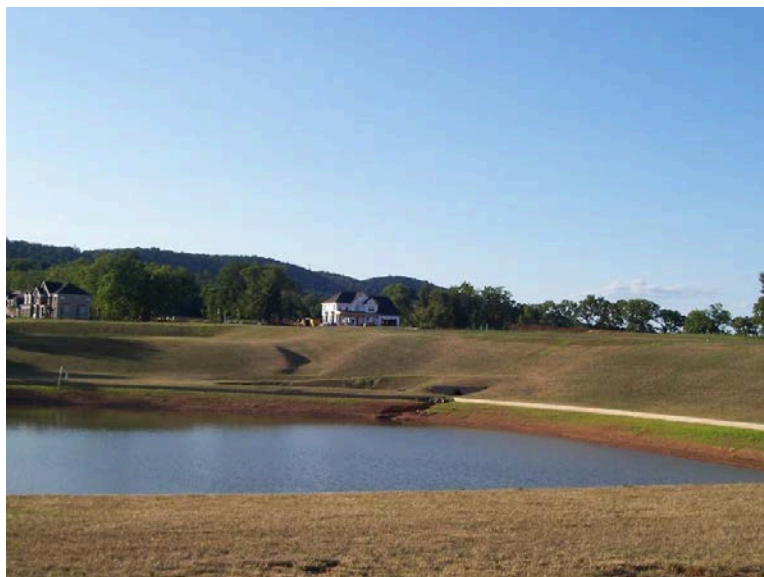
**FIGURE 1:** This image is from July 2, 2007, the lake's first year of full service. Although precipitation in summer 2007 was the second lowest in over fifty years, the lake never went dry.
