REPORT OF GEOTECHNICAL EVALUATION

Canal Run Regional SWM Pond Frederick County, Maryland

November 15, 2012

GTA Job No: 121294

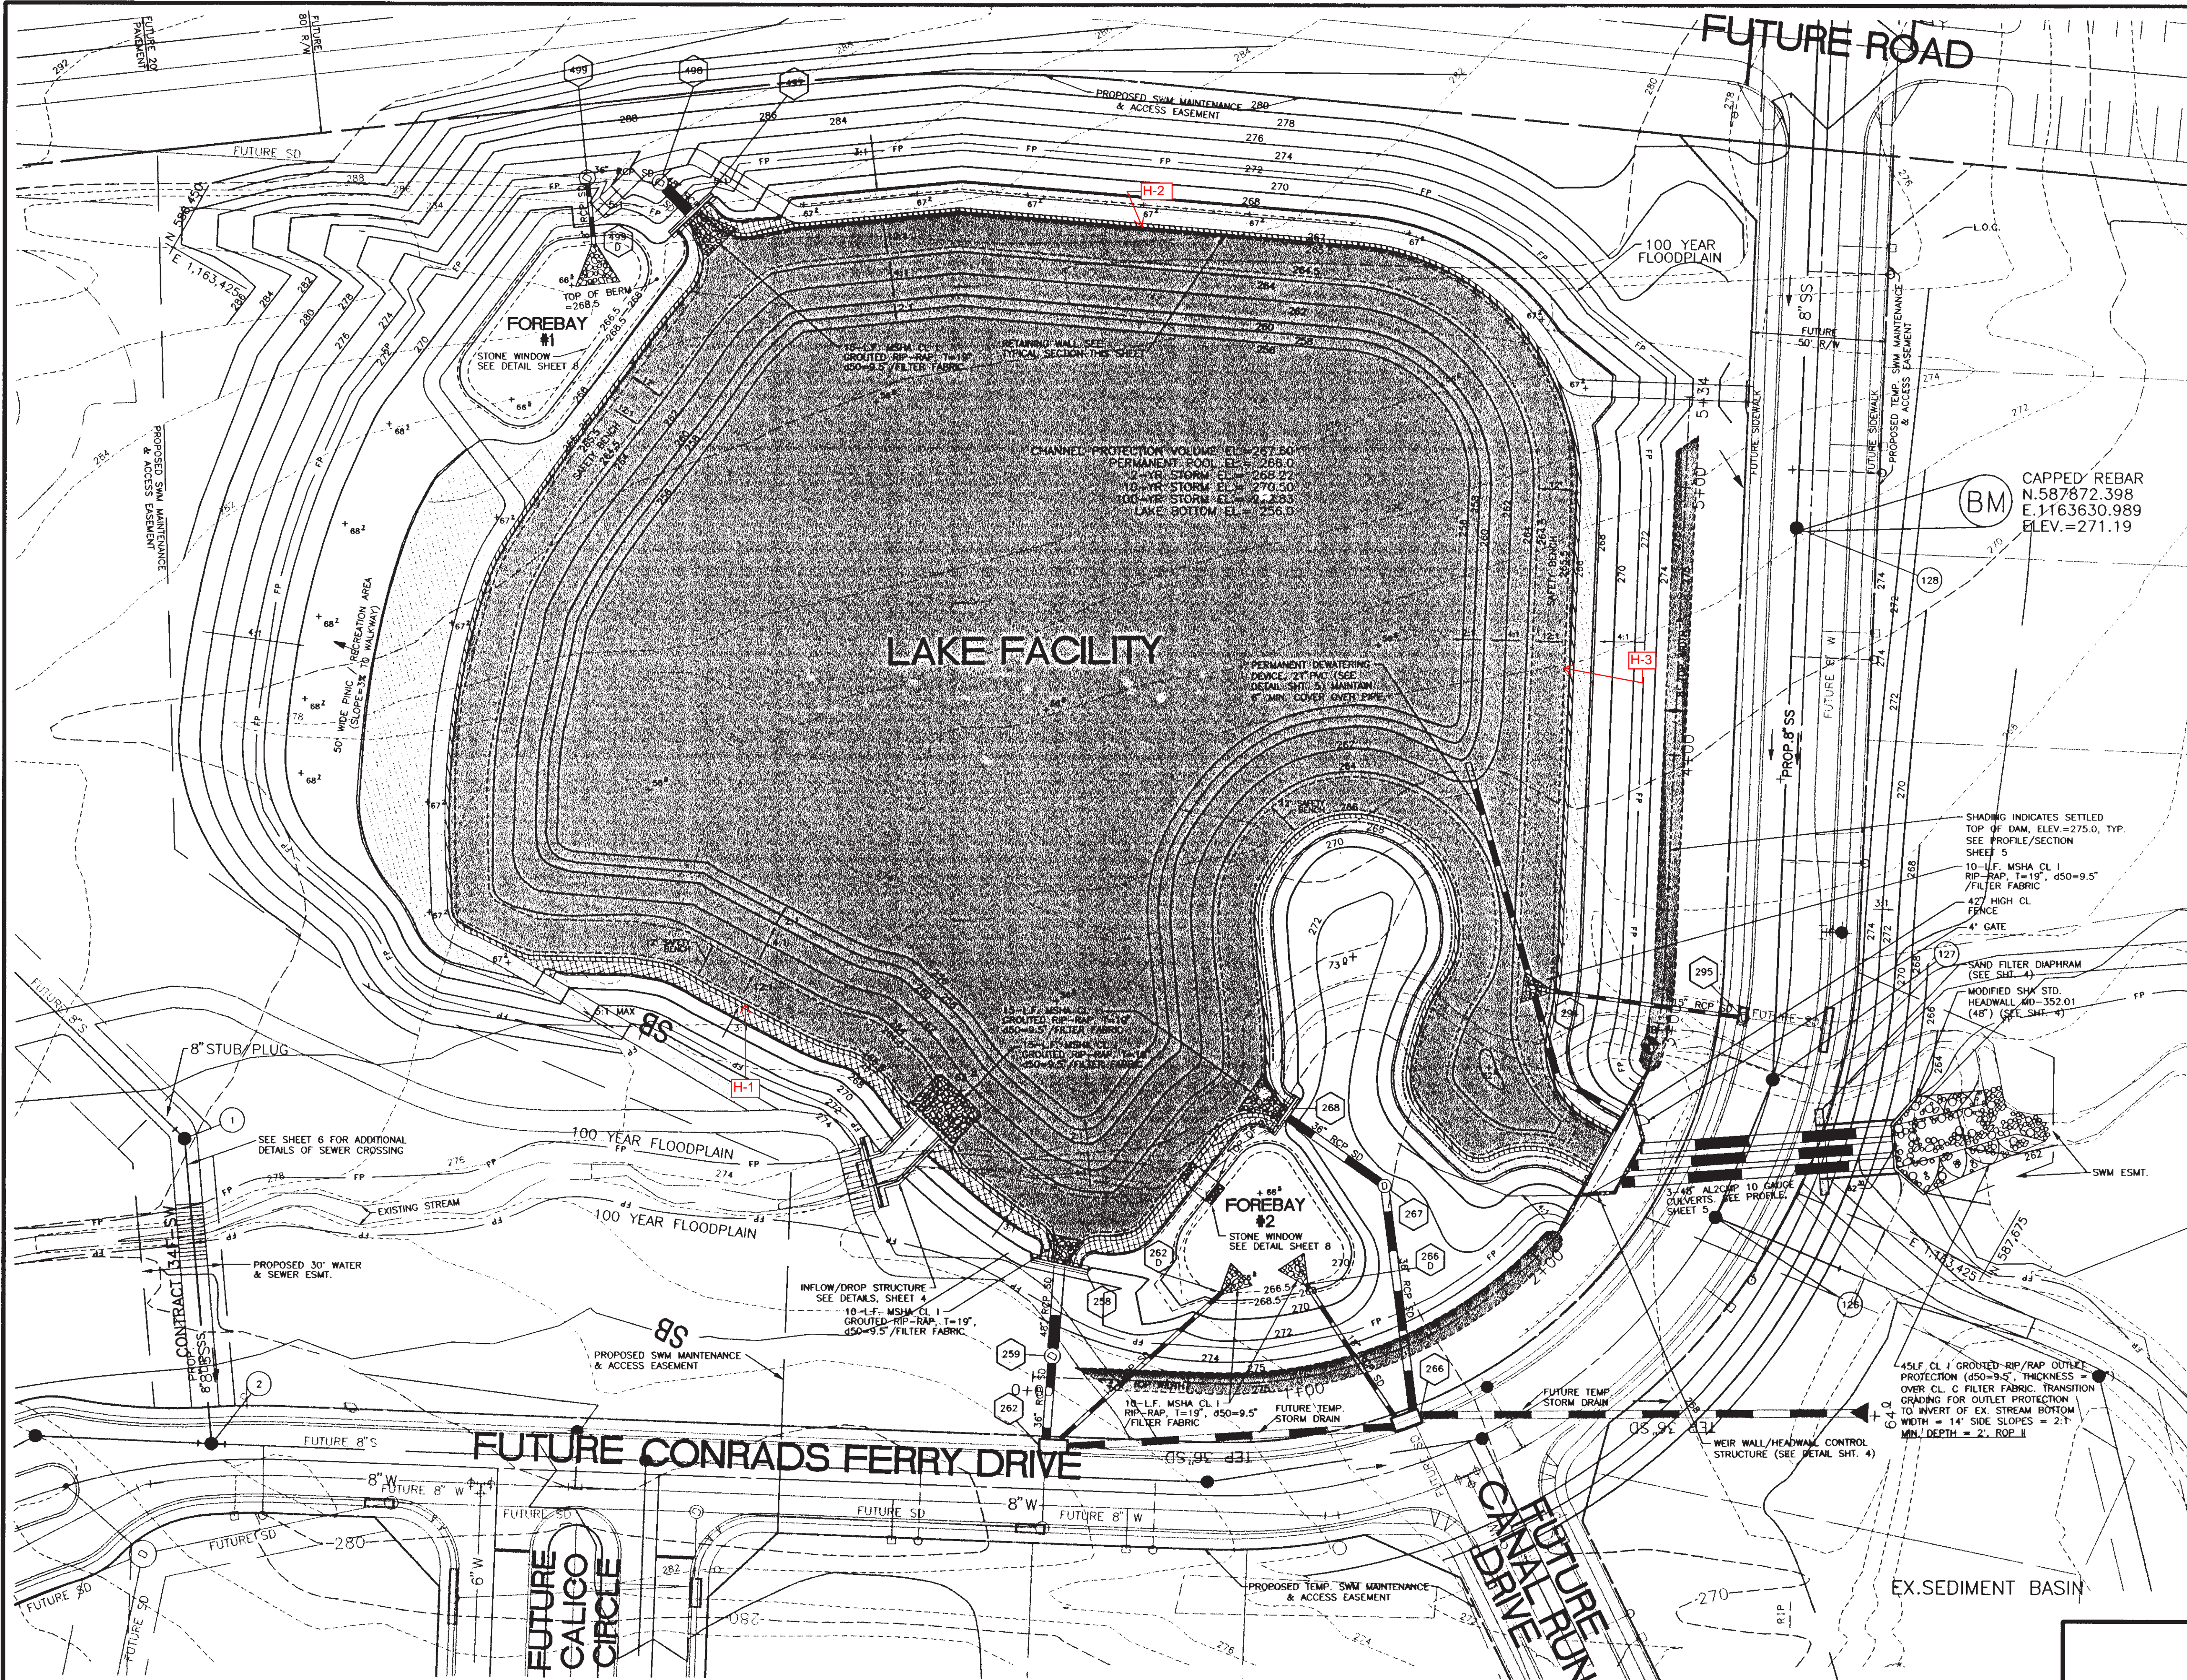
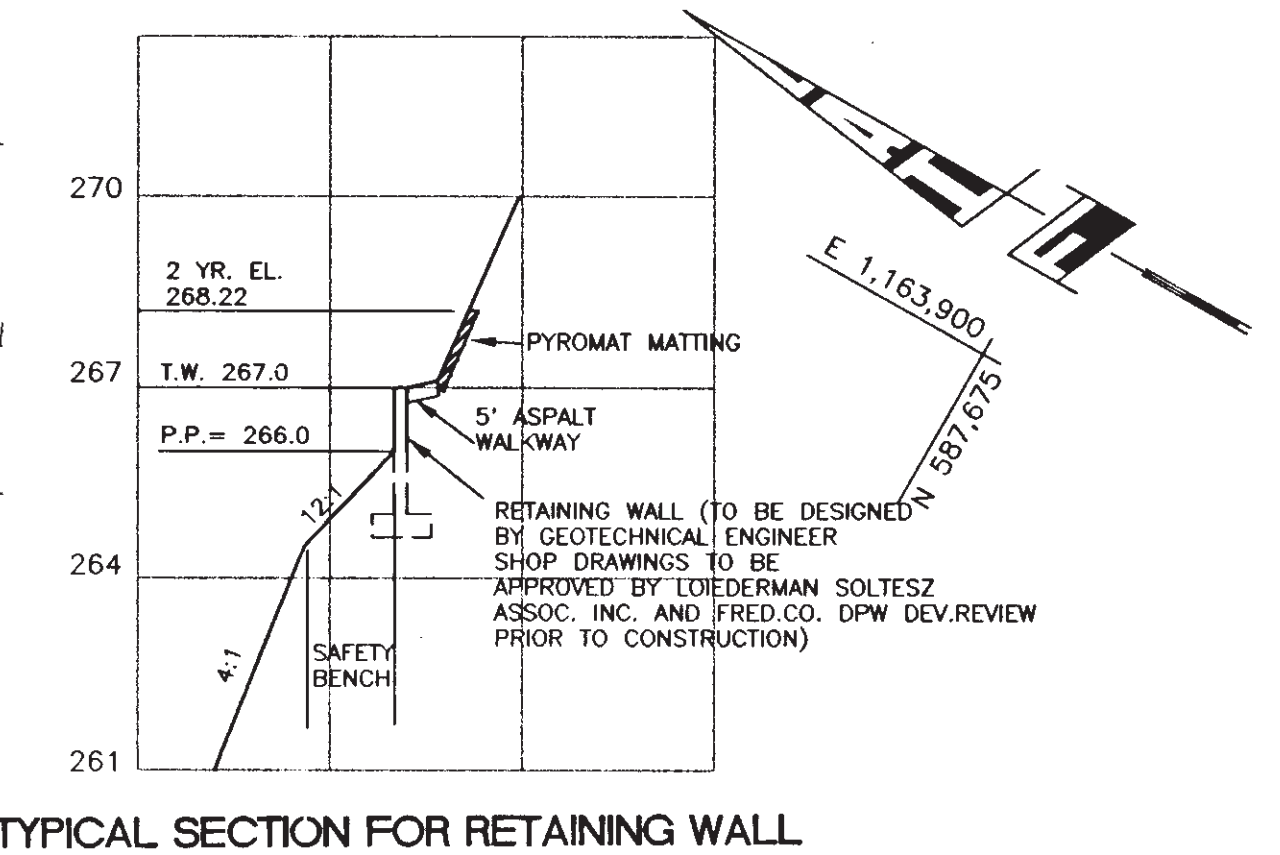
LAKE FACILITY SUMMARY TABLE

TOTAL DRAINAGE AREA =	263.1 ACRES
TOTAL ONSITE DRAINAGE AREA =	113.7 ACRES
WET POOL ELEVATION =	266.0
LAKE DEPTH =	10 FEET
LAKE STORAGE @ WET POOL EL. 266.0 =	18.52 AC.- FT
STORAGE AVAILABLE BETWEEN WET POOL EL. 266.0 UP TO EL. 274.0 =	25.83 AC.FT.
STORAGE REQUIRED FOR 100 YEAR STORM =	21.42 AC.FT.
SETTLED TOP-OF-DAM ELEV. =	275.00

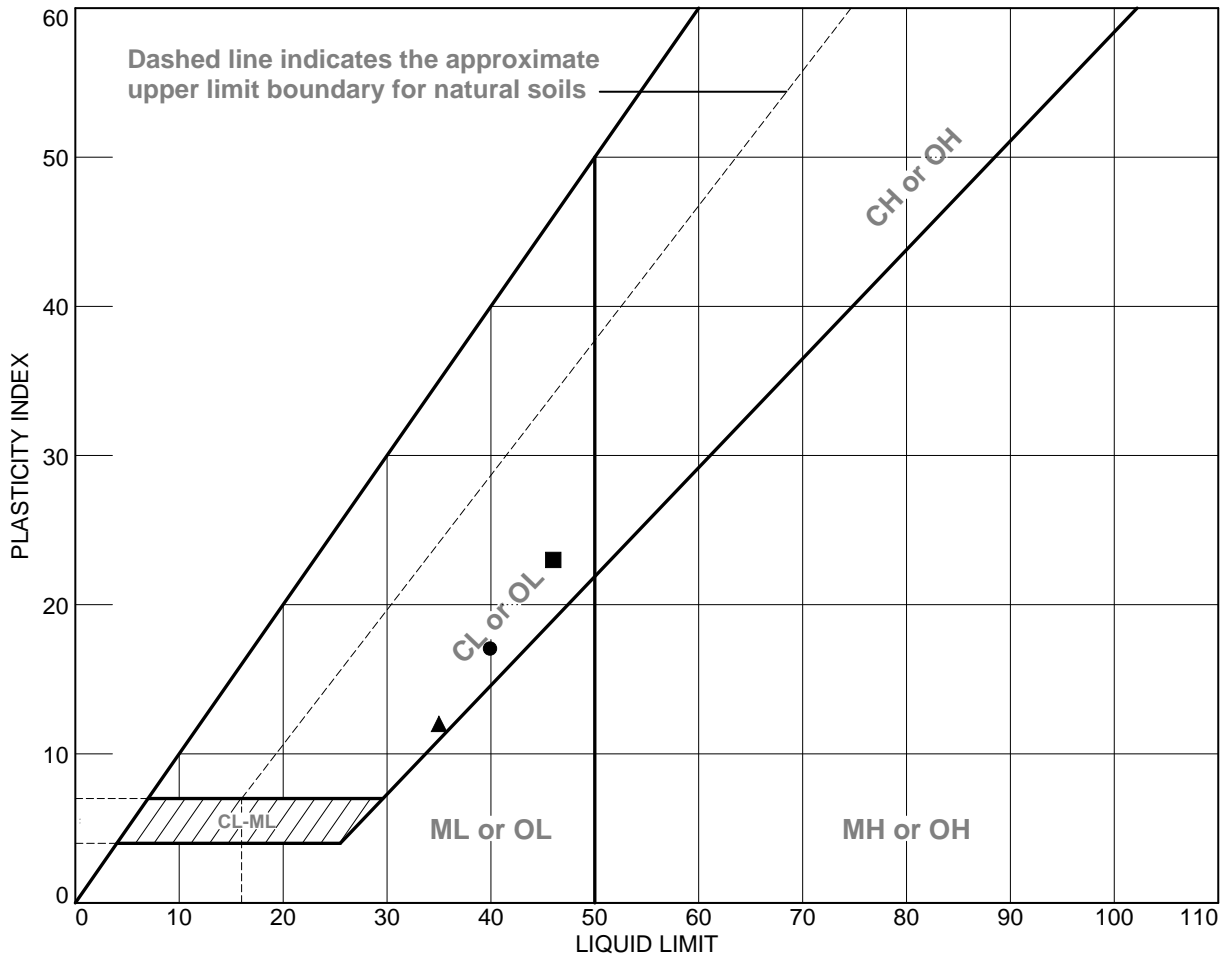
LIQUID AND PLASTIC LIMITS TEST REPORT - ASTM D4318

SOIL DATA								
SYMBOL	SOURCE	SAMPLE NO.	DEPTH	NATURAL WATER CONTENT (%)	PLASTIC LIMIT (%)	LIQUID LIMIT (%)	PLASTICITY INDEX (%)	USCS
●	H-1	1	0	N/A	23	40	17	CL
■	H-2	1	0	N/A	23	46	23	CL
▲	H-3	1	0	N/A	23	35	12	CL
